APPENDIX B. Ground photographs of San Juan and Animas rivers diversion structures.

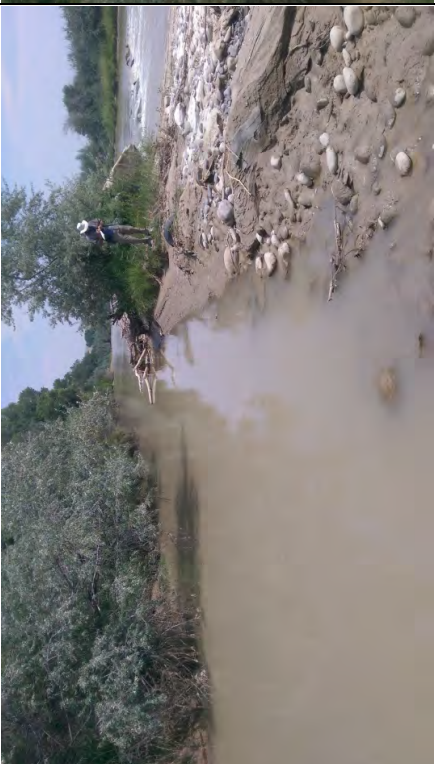
RM 166.3 Jewett Valley Ditch (1 of 2)	  <p>Headgate with non-functioning spillway at left.</p>	  <p>View downstream at headgate.</p>

<p>View upstream from headgate of diversion channel, with head/grade control structure in main channel at right.</p>	  <p>View upstream from headgate of head/grade control structure stretching across main channel.</p>

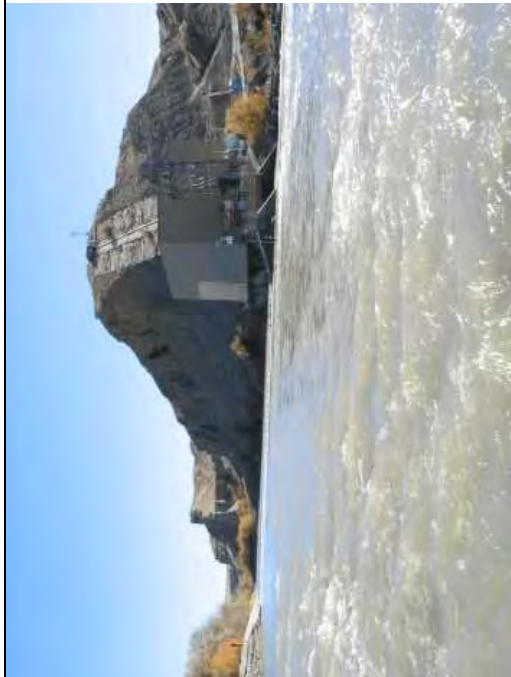
RM 163.7 APS Four Corners Units 4 & 5 (1 of 2)

View upstream of diversion structure.

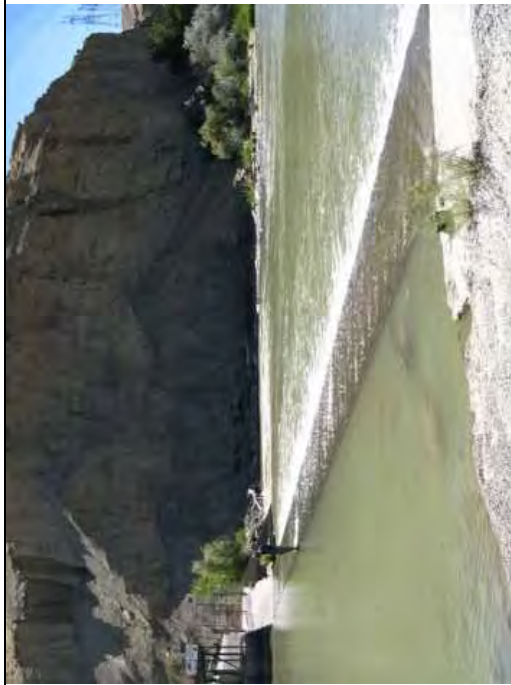
Concrete head/grade control structure.

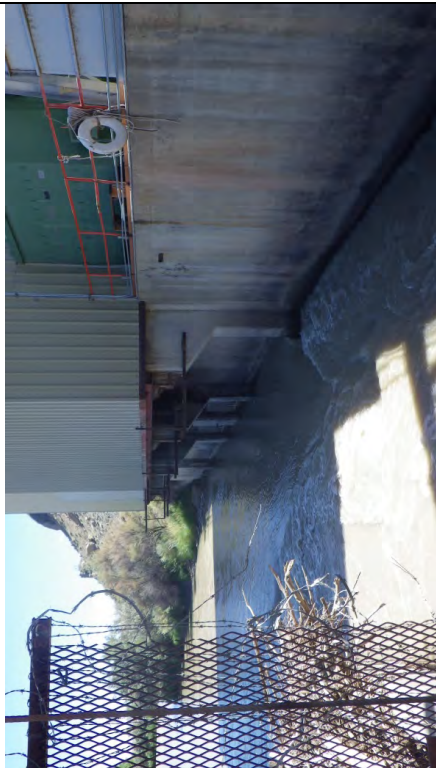
View upstream of diversion channel outlet gate.

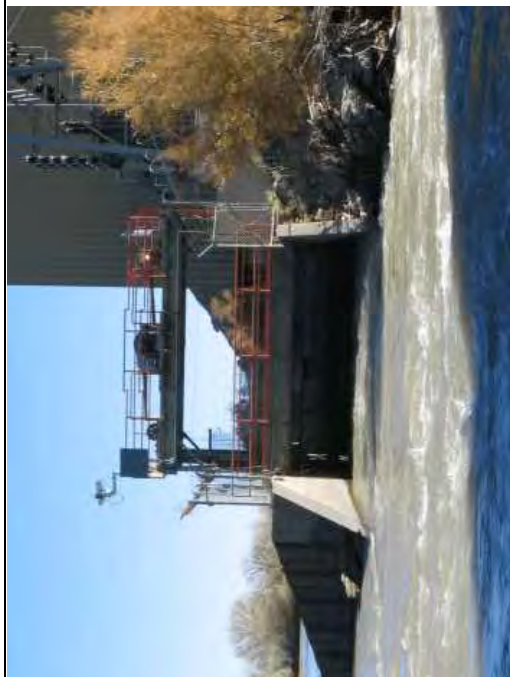
Diversion structure inlet openings with debris/fish screens.

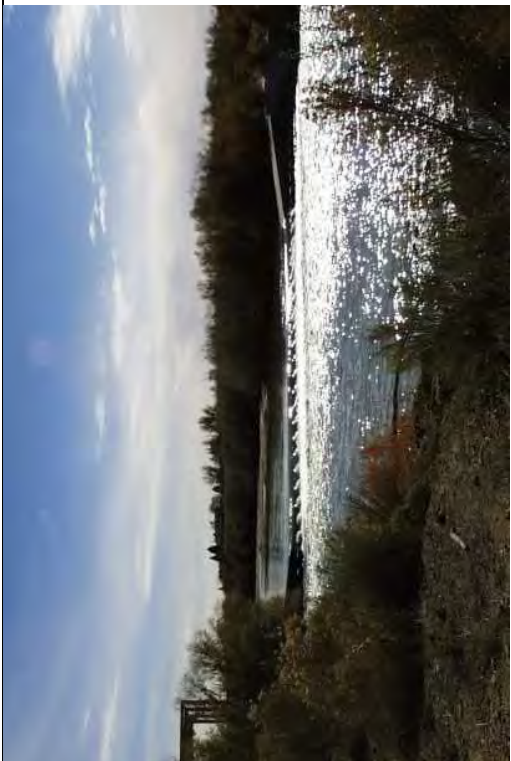
<p>RM 166.7 PNM San Juan Generating Station</p>

<p>View upstream of concrete head/grade control structure, diversion headgate at left.</p>

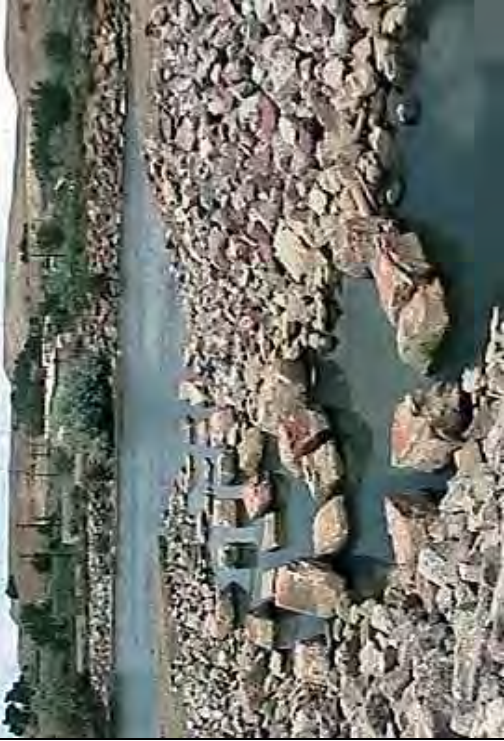
<p>Entrance of fish passage on opposite bank.</p>
---	--	---

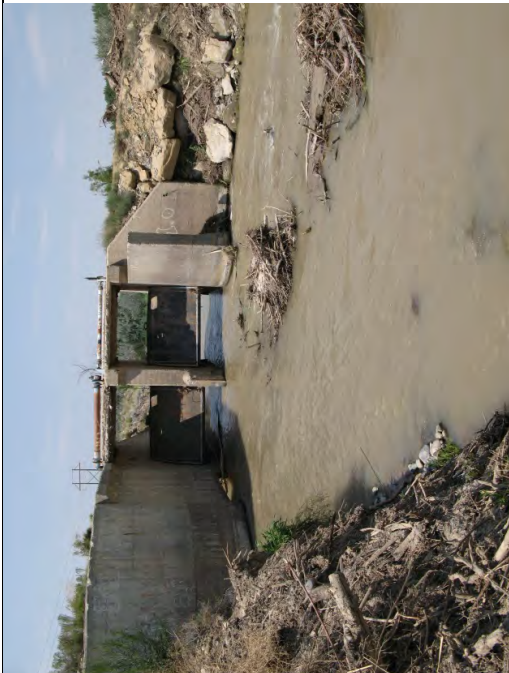
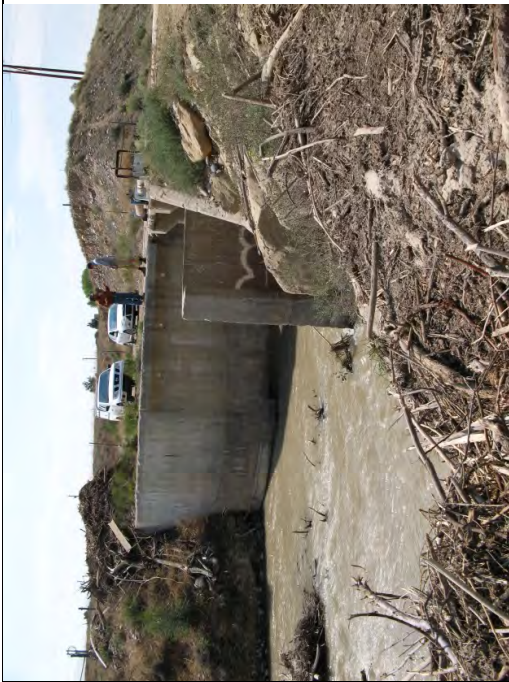
RM 178.4 Fruitland Irrigation Canal/Shiprock Irrigation (1 of 2)

View downstream of headgate structure with gate operators removed.		Headgate structure.

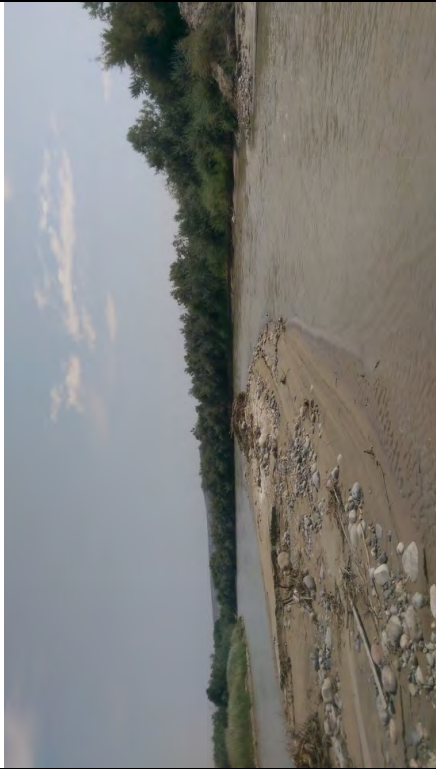
View downstream of canal from headgate.		Headgate structure.

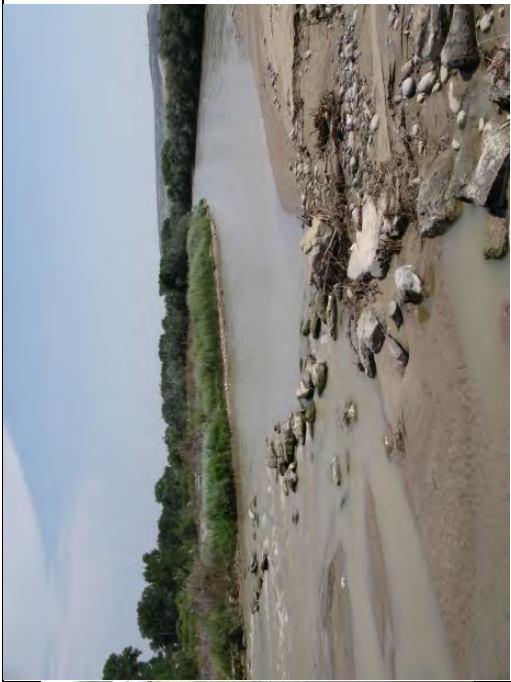
<p>RM 178.4 Fruitland Irrigation Canal/Shiprock Irrigation (2 of 2)</p>	 	<p>View upstream of headgate structure.</p>	 	<p>Spillway gate.</p>

<p>Head/grade control structure.</p>	 	<p>Spillway with diverted water.</p>

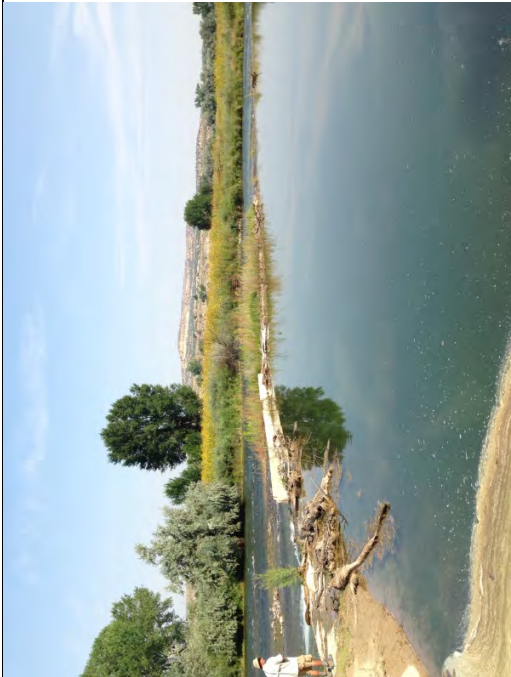
RM 214.4 Turley-Manzanares Ditch (2 of 2)

Head/grade control structure.

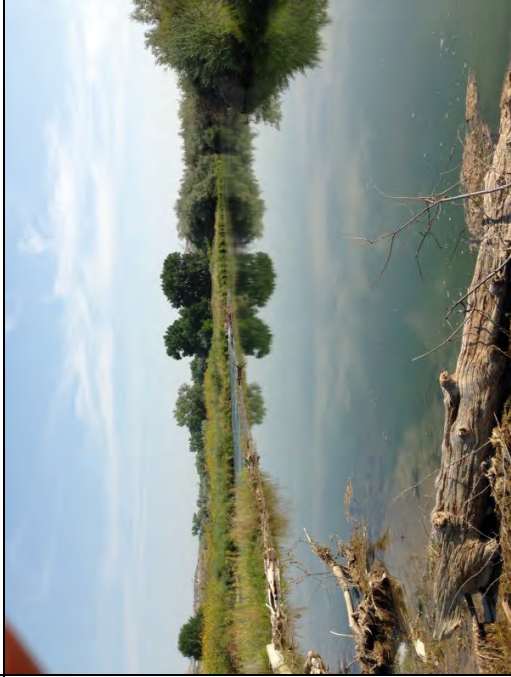
View upstream of ponded area upstream of diversion.

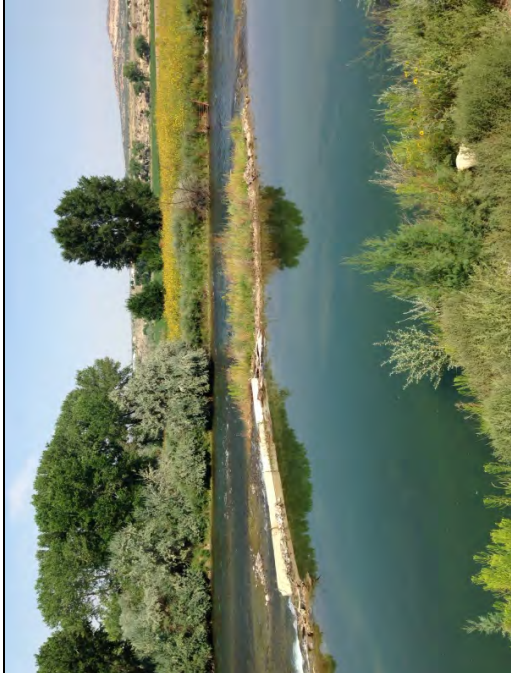
Head/grade control structure with main channel in background.

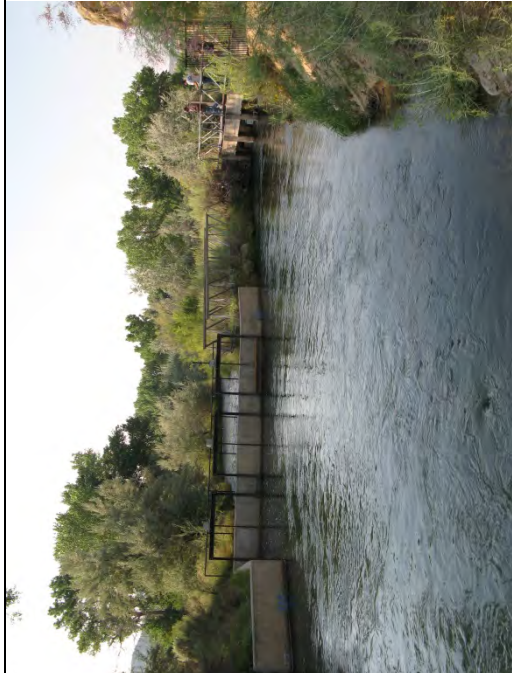
<p>Spillway and headgate structure.</p>

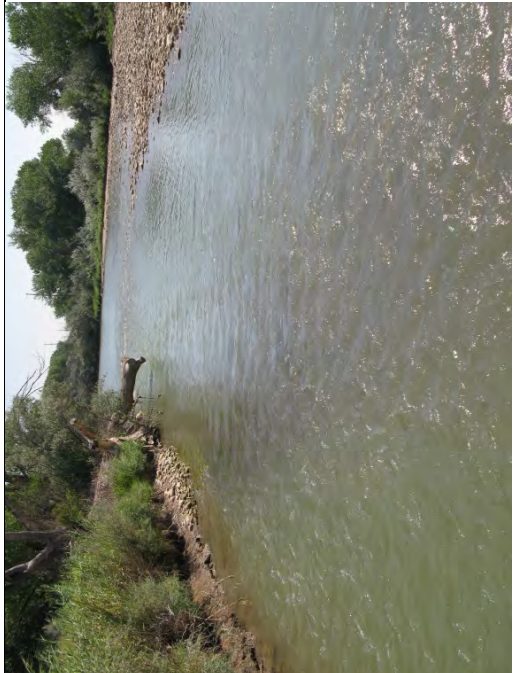
RM 0.4 Farmers Mutual Ditch

View upstream of diversion channel inlet, from headgate; head/grade control structure in main river channel at right.

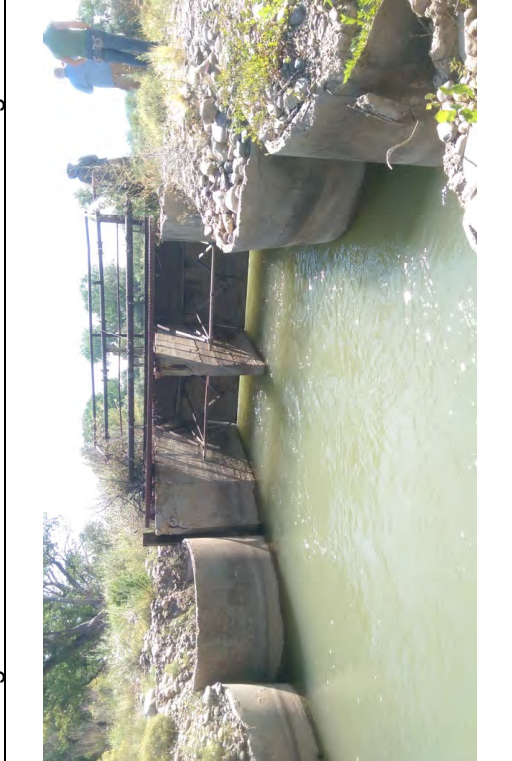
Back of headgate structure, with radial gates.

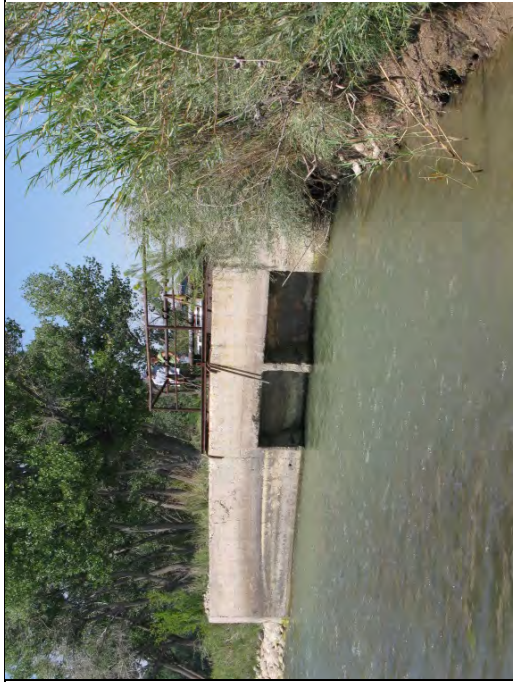
Concrete headgate structure.

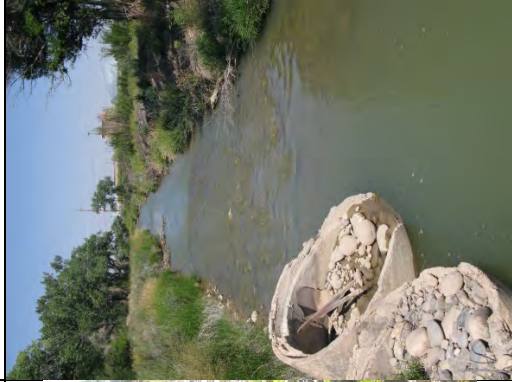
View downstream of ditch, from headgate.

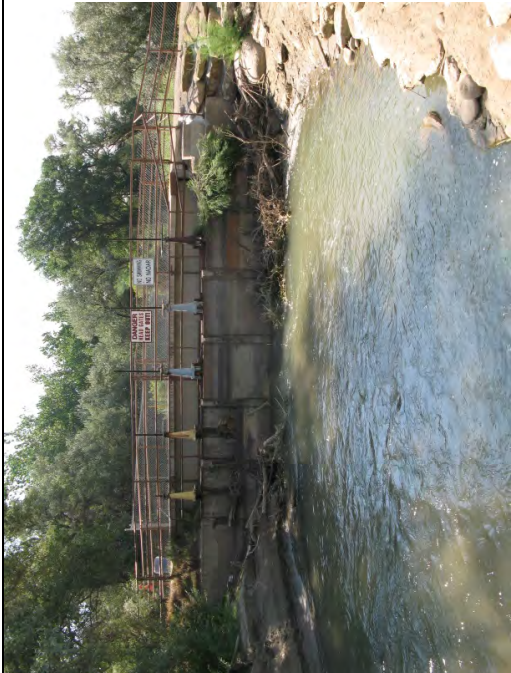
RM 3.5 Willet Ditch

Headgate structure with concrete/boulder head/grade control structure at right.

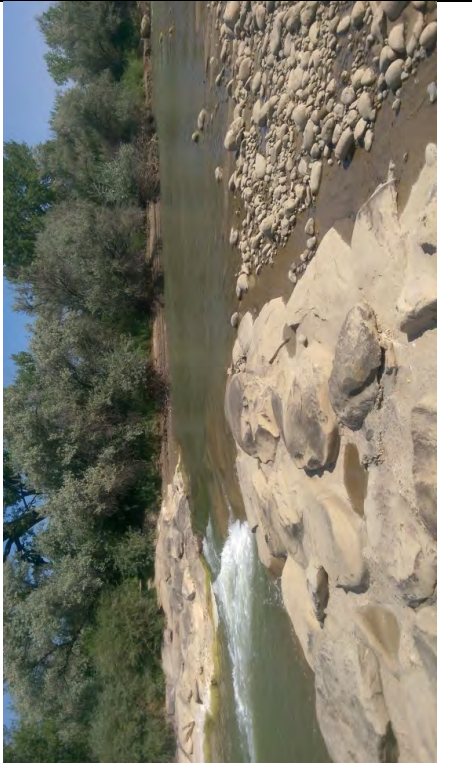
View upstream of concrete/boulder head/grade control structure with kayak hole downstream.

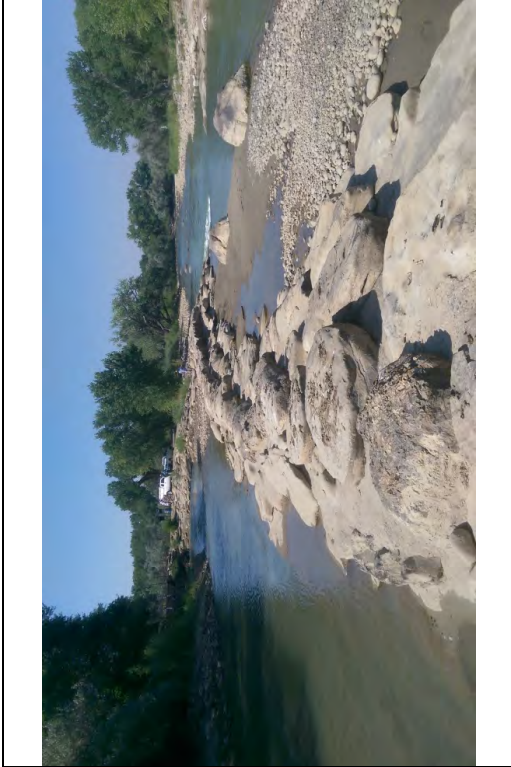
View downstream of headgate structure at left and concrete/boulder head/grade control structure at right.

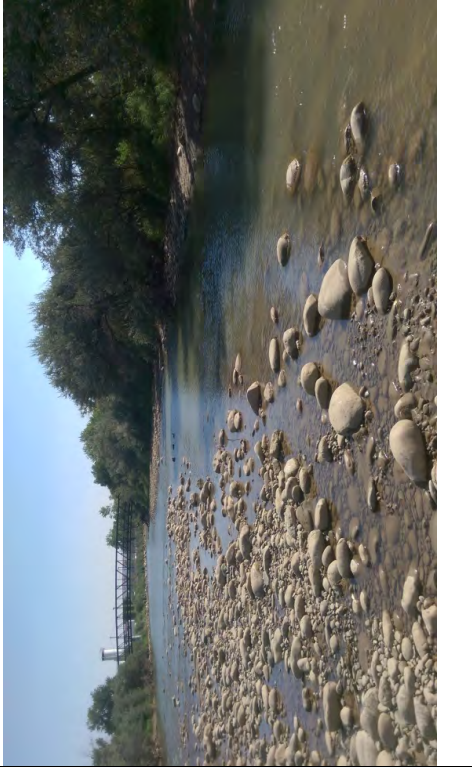
View upstream, diversion channel at right, head/grade control structure at left.

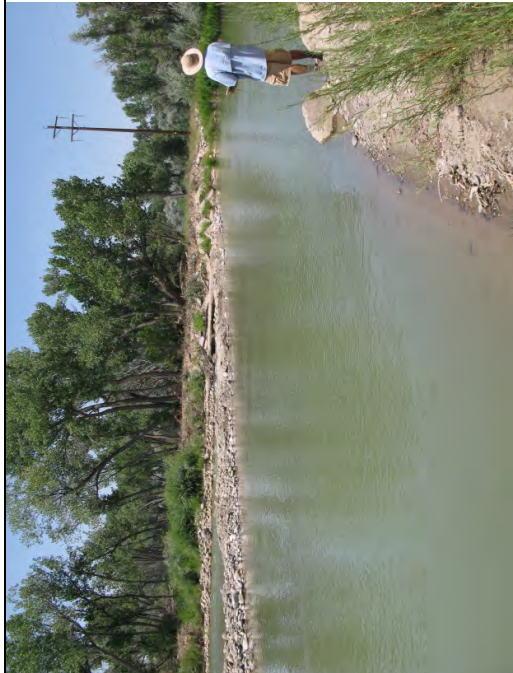
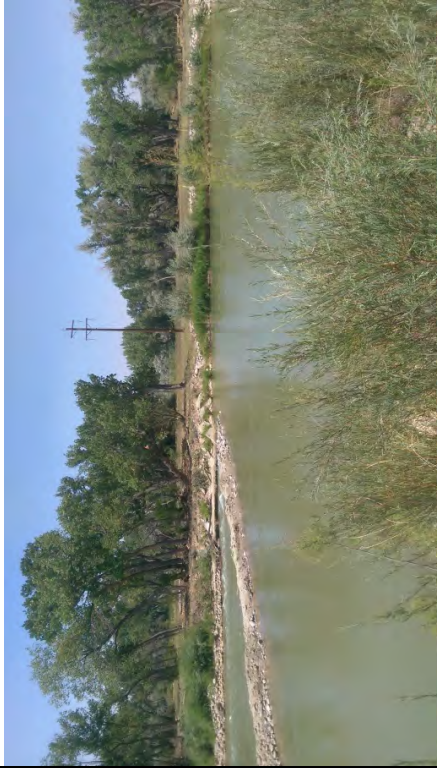
RM 6.1 Farmington-Echo-Allen Ditch

Head/grade control structure at left stretching across main river channel.

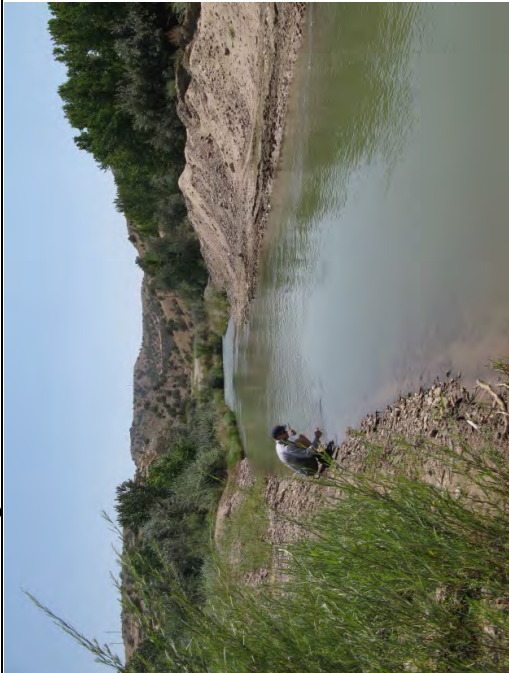
Panoramic view of diversion channel inlet and head/grade control structure.
	View downstream of diversion channel.

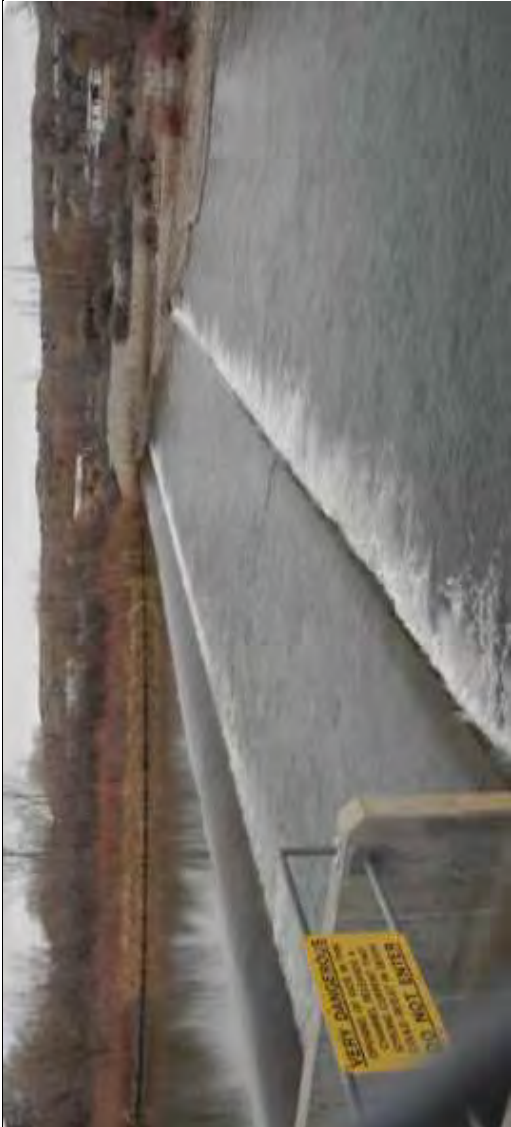
<p>RM 9.5 City of Farmington Animas Pump Station No. 2</p>

<p>Head/grade control structure, with diversion inlet in foreground.</p>

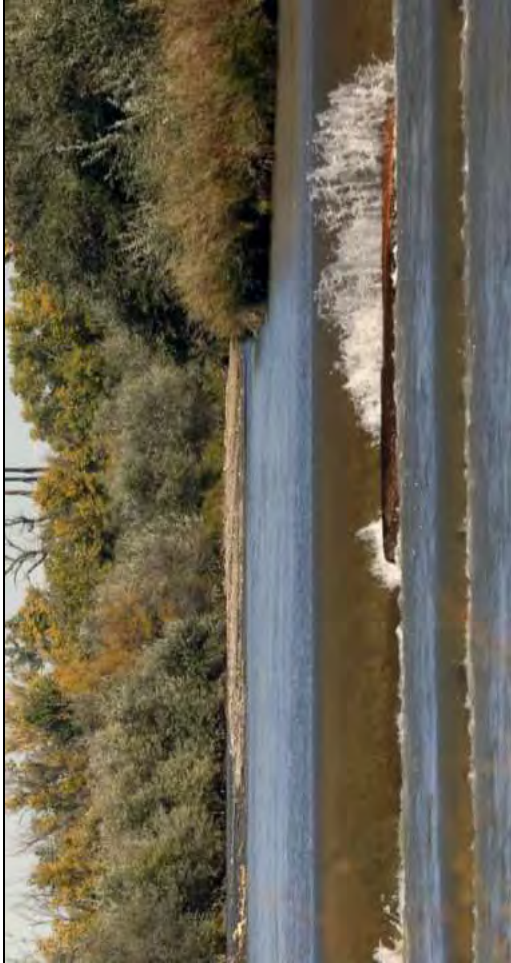
<p>View upstream of head/grade control structure.</p>
--	--	--	---	---

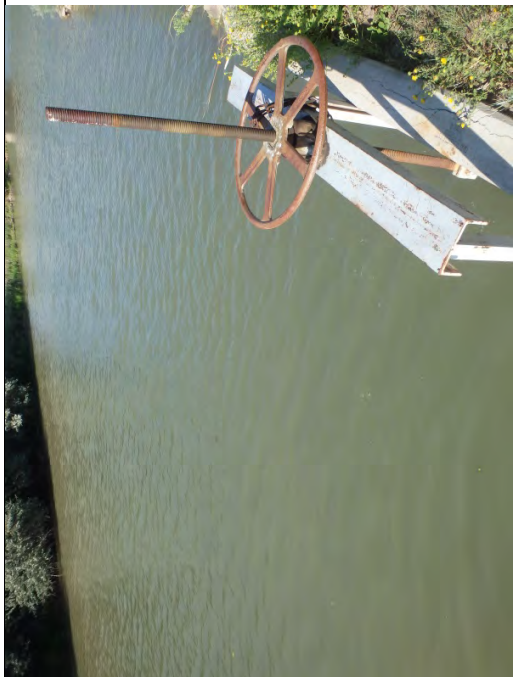
RM 10.8 Ranchmans Ditch

Concrete headgate structure along main river channel.

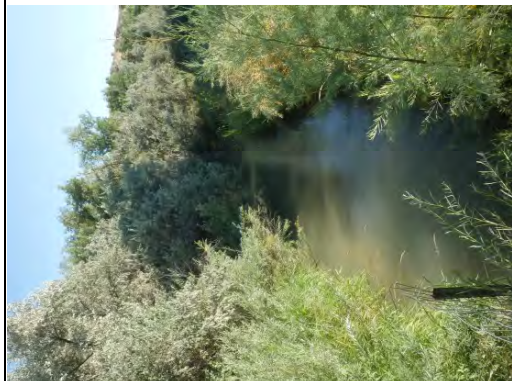
View downstream of ditch, from headgate.

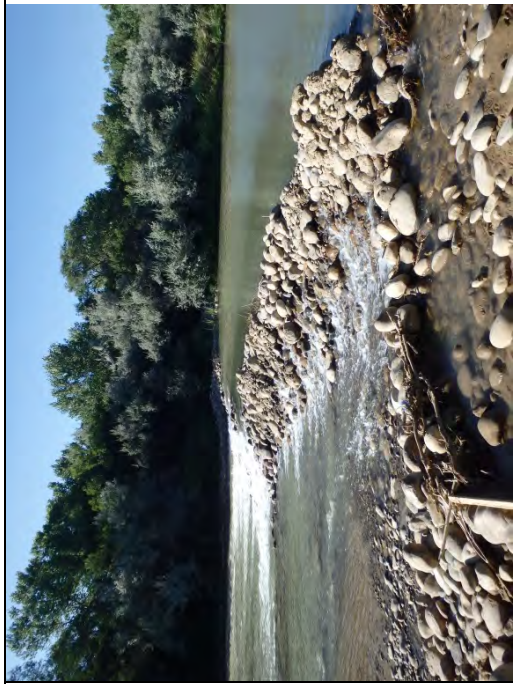
Head/grade control structure in main channel 40 meters downstream of headgate.

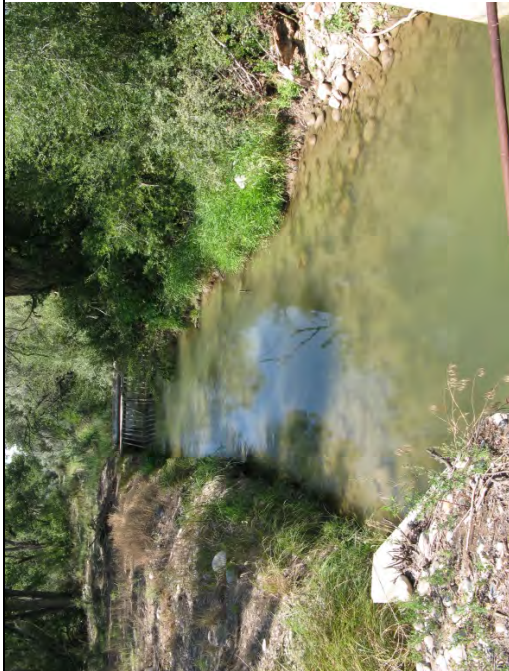
<p>View downstream of ditch, from headgate.</p>

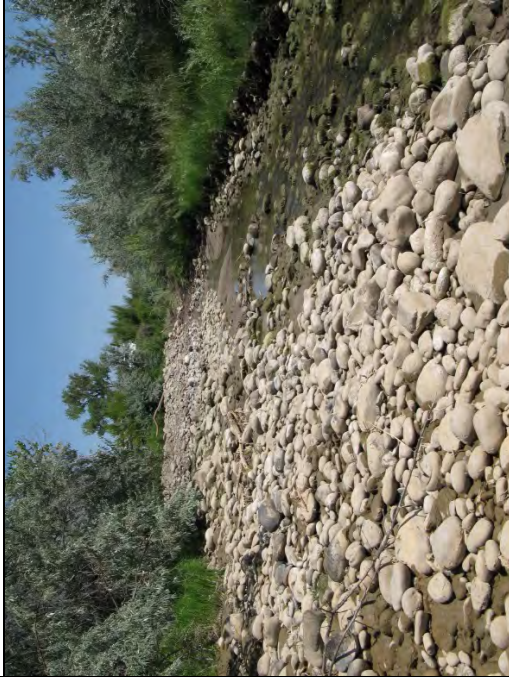
<p>View upstream of return channel below secondary head/grade control.</p>

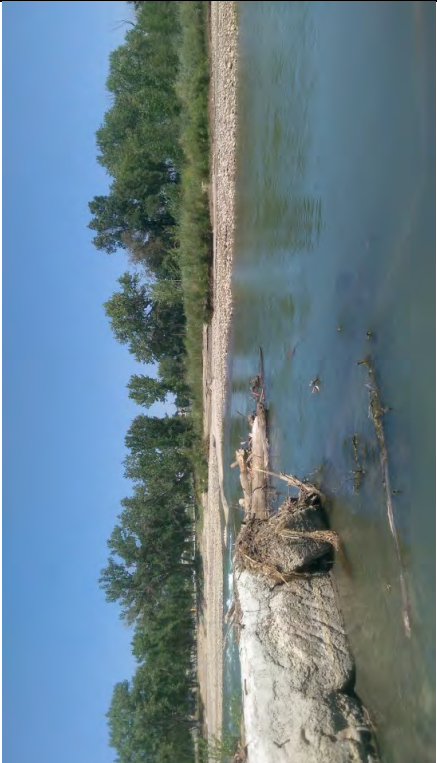
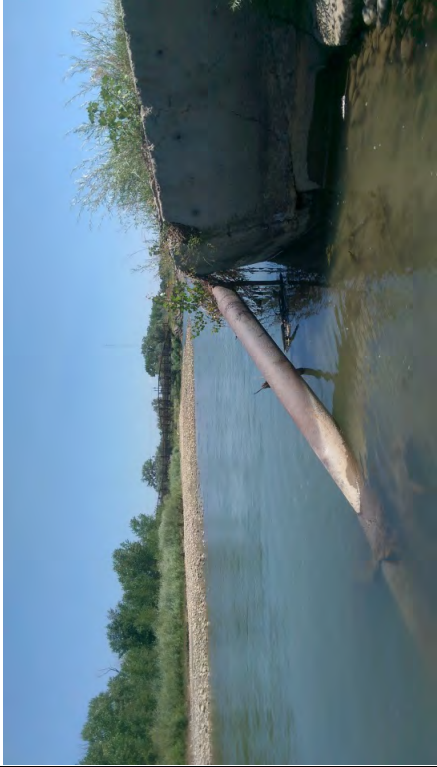
RM 16.8 Kello-Blancett Ditch (1 of 2)

At diversion channel inlet, head/grade control structure in background.

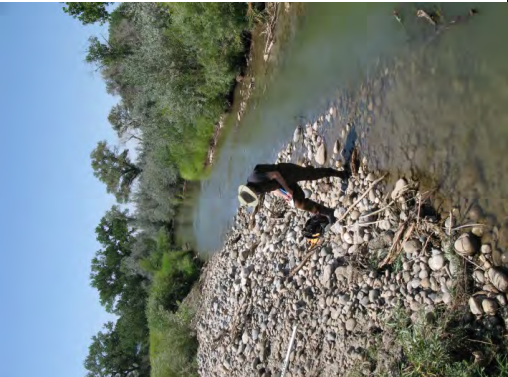
<p>View upstream from diversion channel inlet.</p>

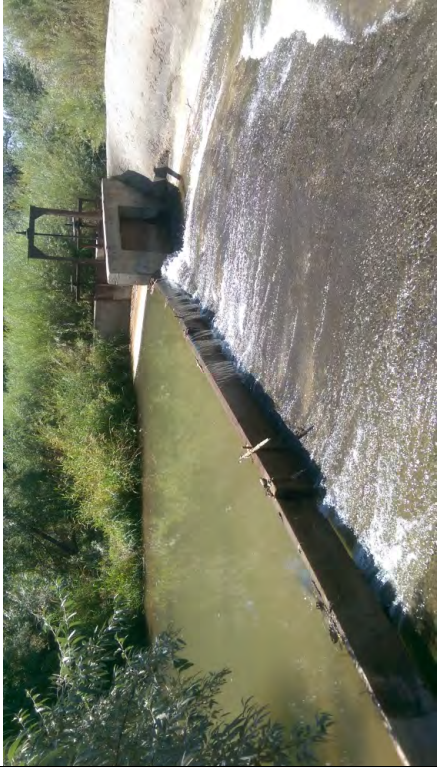
View downstream of diversion channel.		Headgate, spillway gate, and secondary head/grade control structure.

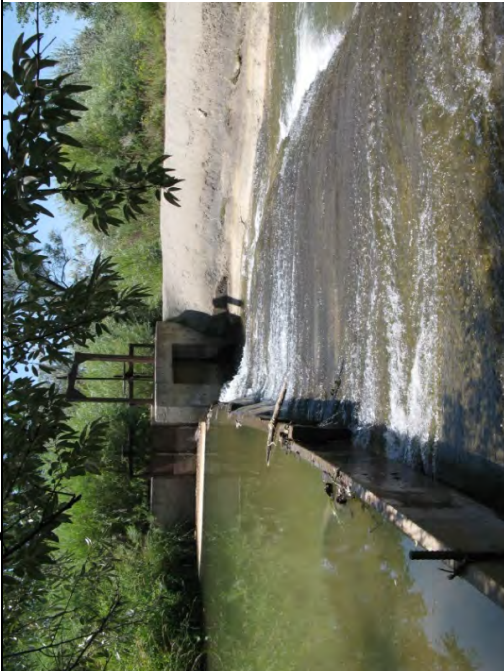
Secondary concrete head/grade control structure.

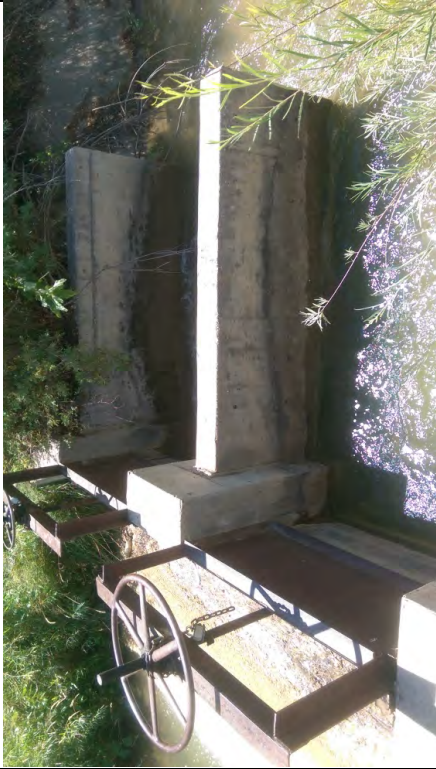
Headgate structure.	 	Secondary concrete head/grade control structure.

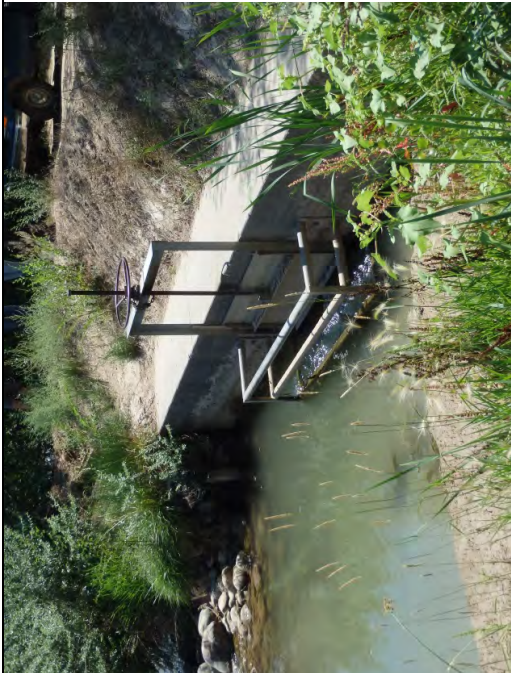
RM 19.8 Eledge Mill Ditch

<p>Headgate structure with trash rack.</p>	  <p>View upstream from headgate.</p>

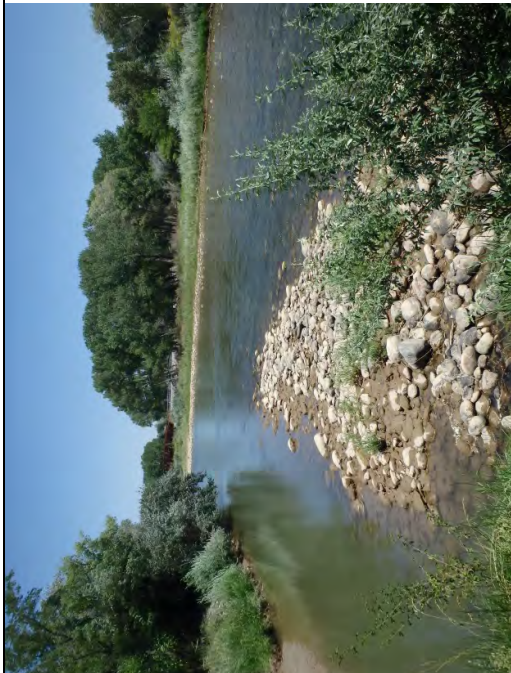
<p>View upstream from headgate.</p>	  <p>View downstream of ditch, from headgate.</p>

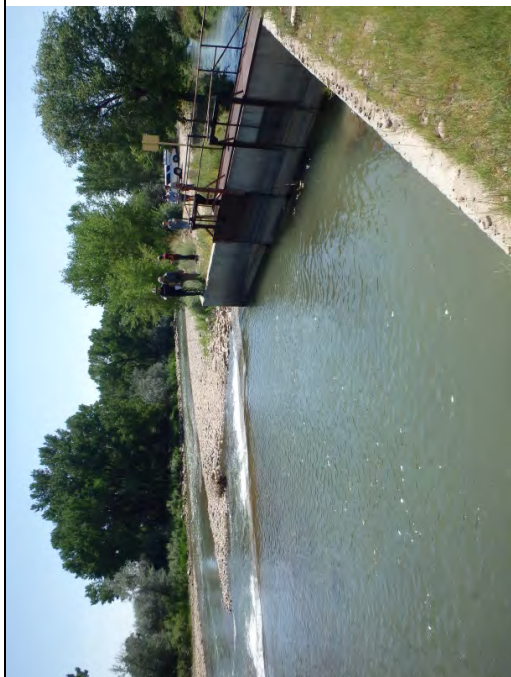
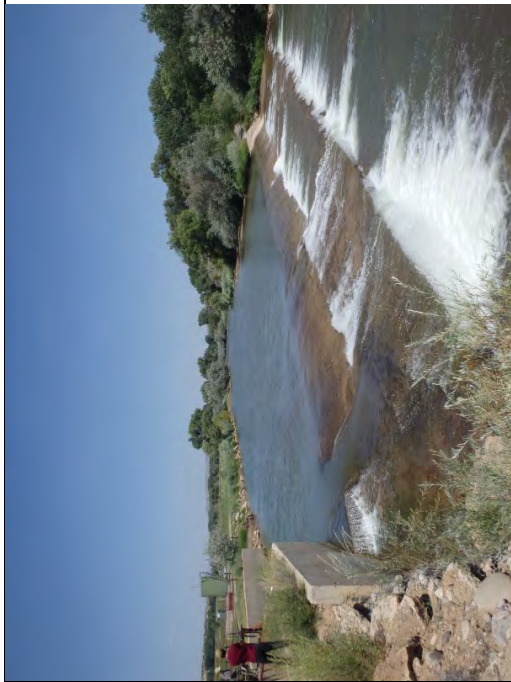
RM 21.4 Farmers Irrigation District (1 of 2)

Headgate structure and head/grade control structure at left.

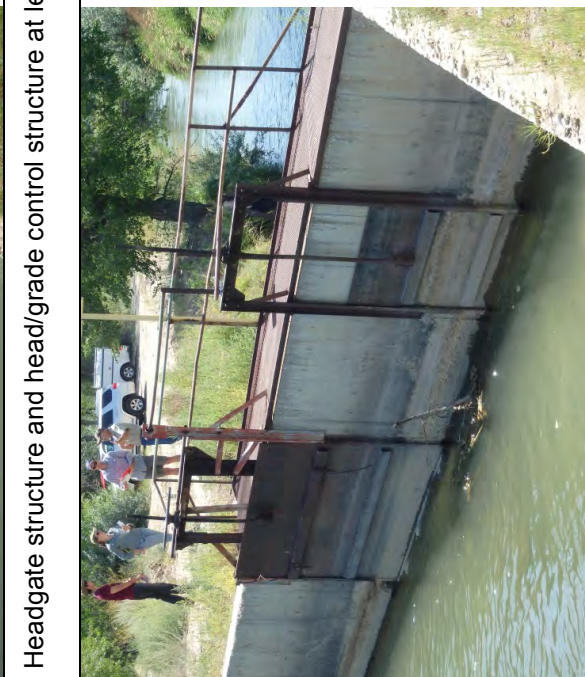
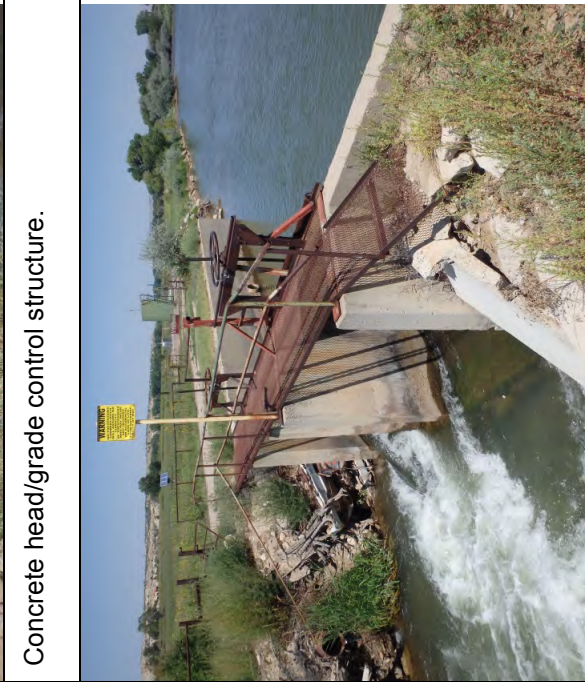
Headgates.		View upstream of headgate structure.

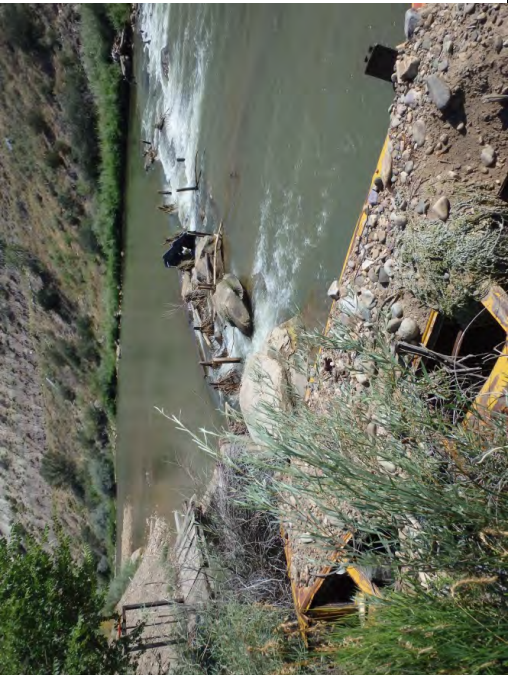
RM 33.8 Cedar Ditch	 	 
View downstream of head/grade control structure and headgate.

View upstream of head/grade control structure.	View downstream of head/grade control structure.

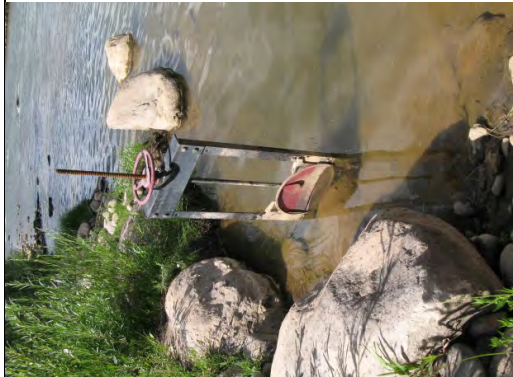
<p>RM 48.9 Dena Ditch/Little Fishes Wildlife Habitat Enhancement Project</p>

<p>Headgate at pipe inlet.</p>

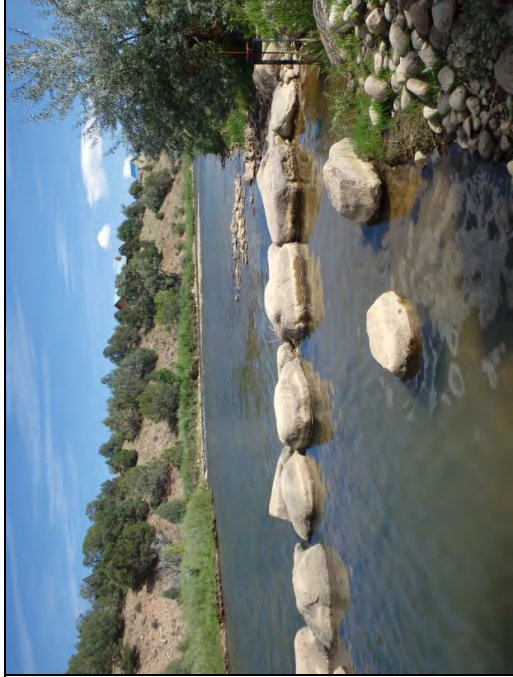
<p>View downstream of head/grade control comprised of large boulders.</p>

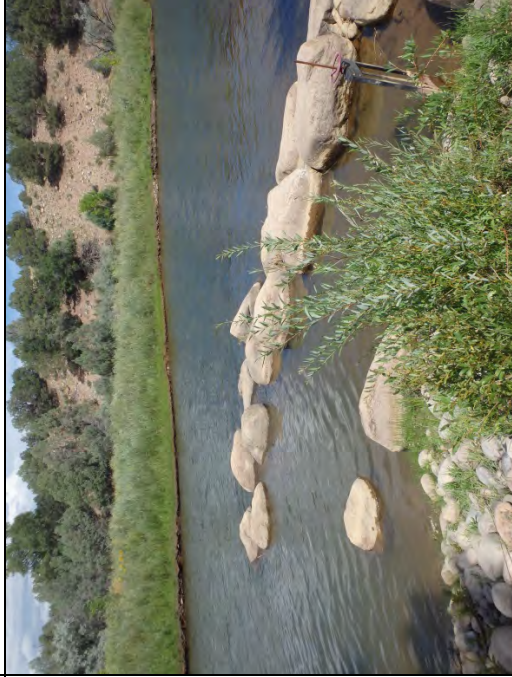
<p>Boulders extending partially across channel.</p>

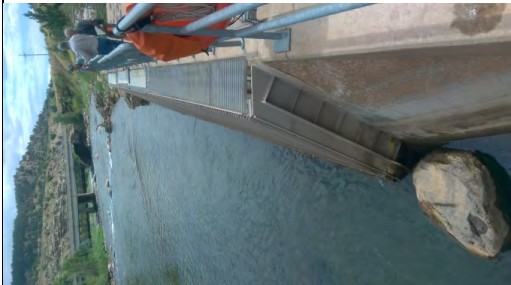
<p>RM 59.8 USBR Animas-La Plata Project/Lake Nighthorse Diversion (1 of 2)</p>

<p>View downstream of diversion structure.</p>

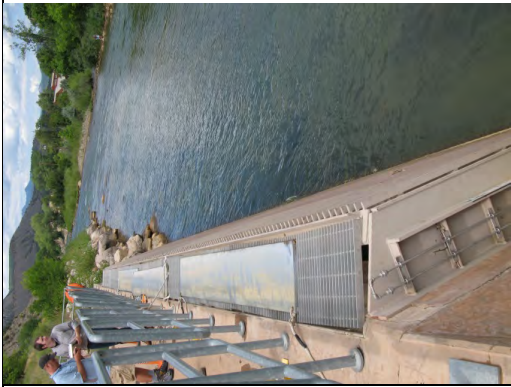
<p>View upstream of diversion.</p>

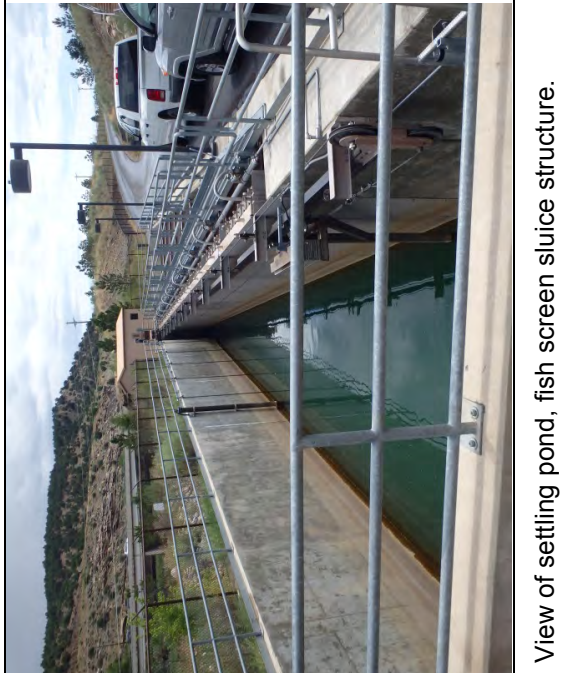
<p>View of settling pond, fish screen sluice structure.</p>

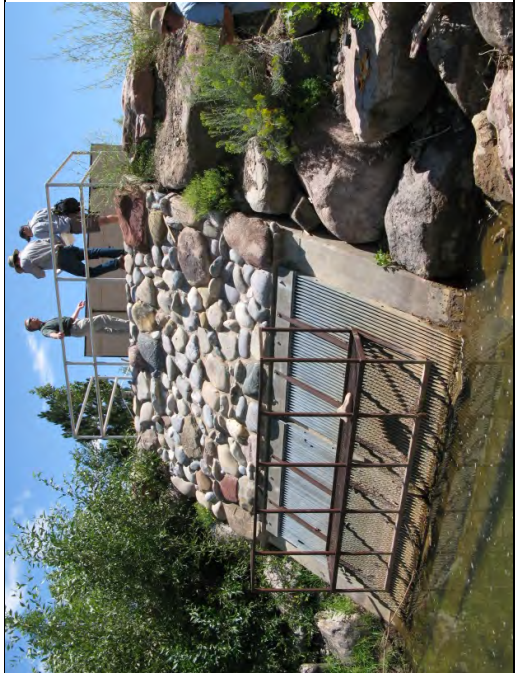
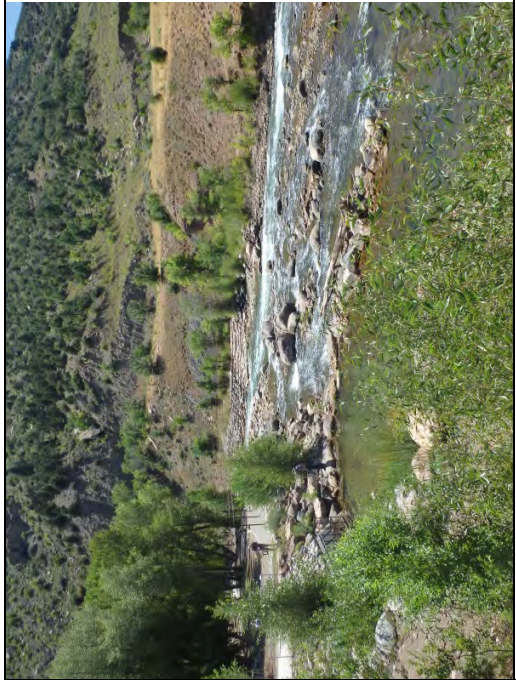
<p>RM 60.2 City of Durango Santa Rita Diversion</p>

<p>View downstream of diversion structure and short head/grade control structure.</p>

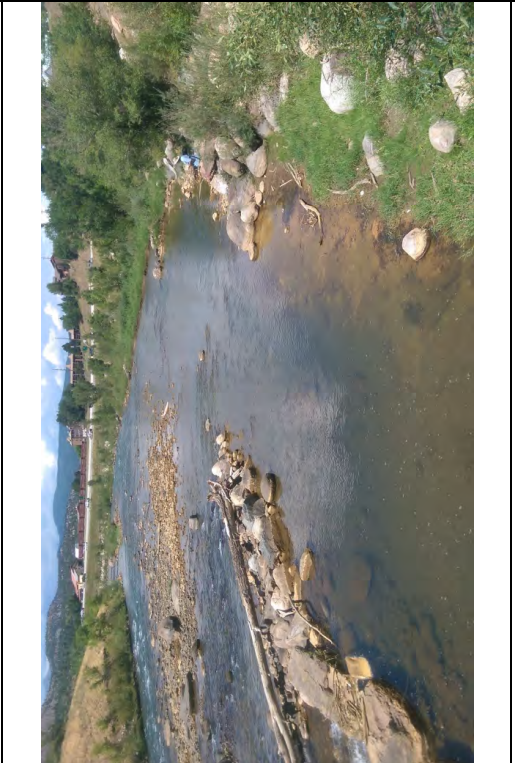
<p>View upstream of head/grade control structure (boulders), from diversion structure.</p>	<p>View downstream of diversion structure.</p>
---	---	--	---	--	---	--	--
